Effects of Climate Change on Fort Patiko Historical Site in Northern Uganda

Patrick Kabwijamu¹*, Agatha Alidri¹, Expedito Nuwategeka¹, Omara John Christopher¹ & Patrick Ochen¹

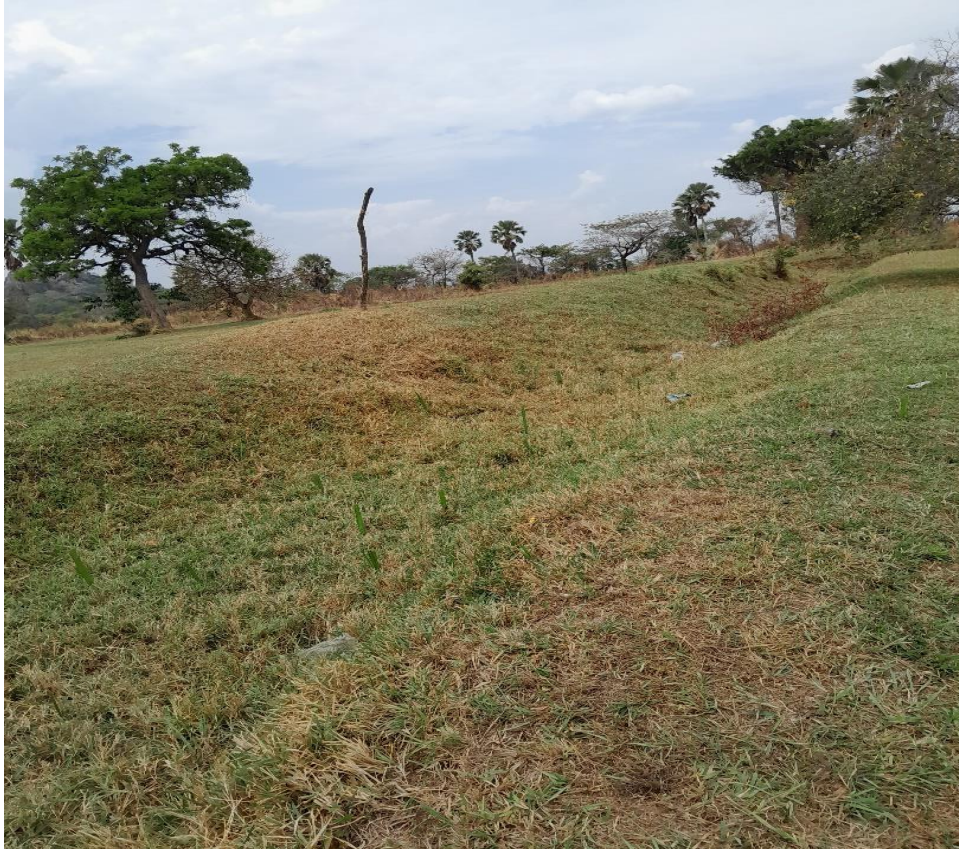
Field Photograph 1: A Widened and Shallow Trench in the Sides

It was noted that the structure of the trench constructed by the Arabs to prevent the escape of slaves had been denatured by running water resulting from the heavy downpour of rain and surface water runoff from the hilltop. Sections of the trenches were widened, deepened and shallow as they were filled with soil deposits. According to the measurements and observations made during the survey, the space between the trench had changed significantly from 10 to 22 feet wide, compared to the measurements in the archival records. The depth of the trenches was observed to be shallow due to the piles of sand and soil deposits in the trenches. Measurements taken from one part of the trench show a decrease in width from 10 to 8 feet in some sections and 7 feet in others. This indicates that the rocks have been worn off or shifted position.

It was noted that the area to the left of the "Gate of no Return" measured 12 feet because running

water passes through the illegal access route from Ajulu Hill to the centre. Therefore, it is anticipated that this will become more profound as the rains increasingly wash away the trench bed. However, the structure of the trenches at the Fort is irregular. This discloses that the illegal pathways from Ajulu Hill allow water to flow directly into the trench, exacerbating erosion and altering the trench's dimensions. Moreover, the natural topography of the area, combined with irregular trench structures, makes the site more susceptible to erosion, particularly during heavy rains.

The researcher observed that continuous erosion could undermine the foundation of the "Gate of No Return" and other structures within the Fort, leading to potential collapse or significant structural damage. This causes the historical features and artefacts around the Fort to be eroded or buried by sediments, hence the loss of valuable cultural heritage.

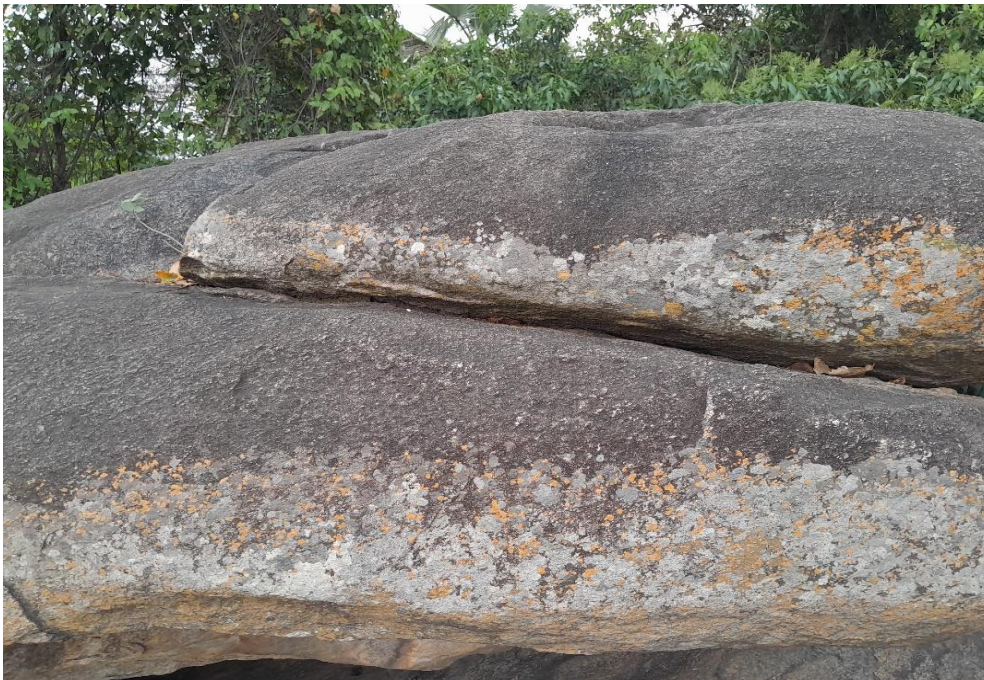
Field Photograph 2: Darkened Rocks Due to Exposure to the Sun's Heat

From observations of the rocks, climate change effects were visible at Fort Patiko. A total of 5 (1%) study respondents submitted that high temperatures and heavy rains affected the colour and texture of the rock. Temperature measurements were taken, and results showed that the rock temperature was at 38 degrees, with wind speed at 10km/h. The colour of the rock changed from white and shiny to dark, reddish brown due to high temperature and heat. This was attributed to the long dry seasons and droughts that had become frequent in recent years (Interview with Fort Patiko caretaker). It is predicted that the rock may turn dark brown. The prolonged exposure to higher temperatures causes physical and chemical changes in rocks. The heat can lead to oxidation processes that alter the mineral composition and colour of the rock. Changes in environmental conditions, such as increased humidity and temperature, can promote microbial growth on the rock surface. Certain microorganisms produce pigments that contribute to colour change.

The change from a white and shiny appearance to a dark reddish-brown significantly alters the visual appeal of the Fort. This detracts from the site's historical authenticity and attractiveness to visitors and alteration of the cultural narrative and heritage associated with Fort Patiko. Changes in the rock's colour and composition can make it more susceptible to erosion and weathering, accelerating the deterioration of the rock and the overall structure. Continuous exposure to adverse climatic conditions can compromise the structural integrity of the rock, posing risks to the stability of the Fort. The observation that the rock at Fort Patiko has changed colour from white and shiny to dark reddish-brown due to excessive heat underscores the impact of climate change on cultural heritage sites. This discolouration not only affects the visual and historical appeal of the site but also serves as an indicator of broader environmental changes.

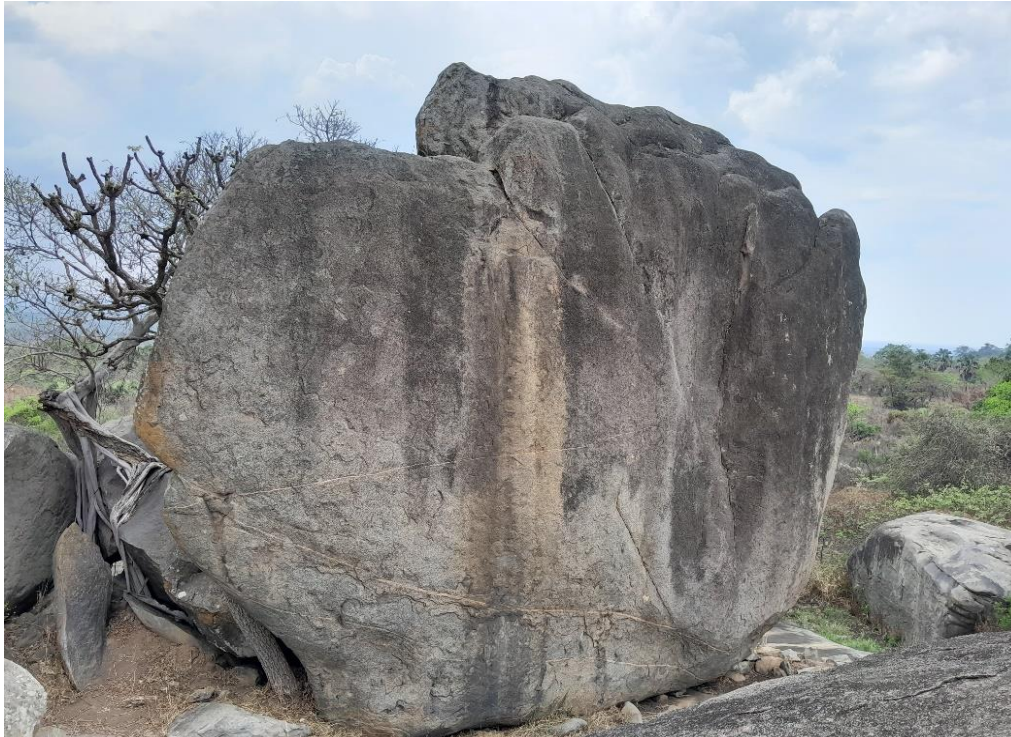
Field Photograph 3: Lines of Weaknesses on the Rock

Furthermore, 20 (40%) respondents acknowledged the effect of climate change on the rocks and noted that the rocks were also breaking

into boulders due to high temperatures. The observations revealed that some of the broken pieces were from bigger rocks, and this may continue to break evidenced by the cracks and many lines of weaknesses on the rocks¹. The study deduces that rocks expand when heated and contract when cooled. Repeated cycles of expansion and contraction, driven by daily and seasonal temperature fluctuations, can create stress within the rock. This stress can exploit existing lines of weakness, leading to fractures and eventual breakage. High temperatures can accelerate weathering processes, particularly in rocks with existing vulnerabilities. The fragmentation of larger rocks and boulders into smaller pieces can destabilize the rock formations, posing risks to the fort's structural stability. This can lead to collapses or significant damage to historical features, continued breaking of rocks weakens the foundation of the fort and its

¹ Mr. Ronald, the caretaker of Fort Patiko, highlighted two significant issues affecting the stone lining at the execution centre. Firstly, the lining of the rock separating the execution center is gradually collapsing due to expansion and contraction caused by environmental factors. Secondly, the rock arrangement was disrupted by the actions of the Lord's Resistance Army (LRA) soldiers. Additionally, community members have been removing stones from the site for quarrying purposes. Stones used in construction expand and

contract in response to temperature fluctuations and quarrying disturbances. Over time, this movement can weaken the mortar holding them together, leading to structural instability and eventual collapse. Exposure to rain, wind, and other weather conditions gradually erodes the mortar and weakens the bond between stones.

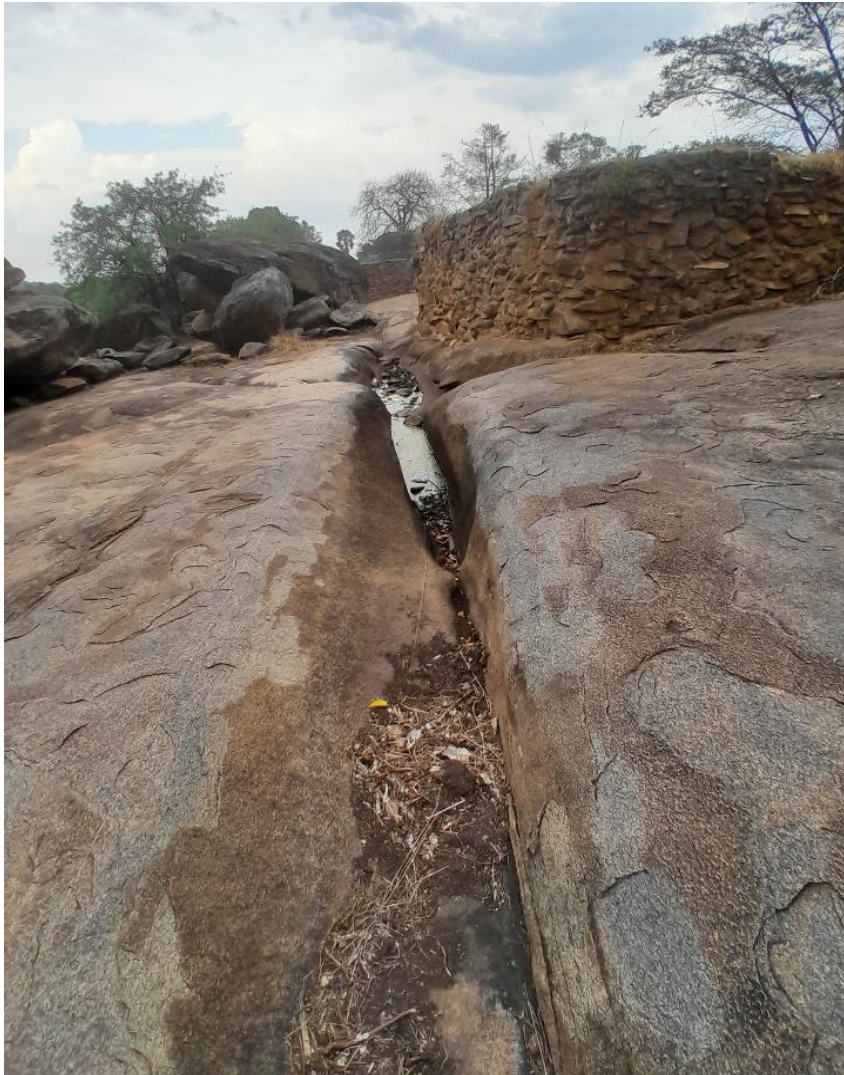
Field Photograph 4: Tortoise Stream Drying off

A total of 6% of the respondents observed that there was a possibility the tortoise stream would dry out at one point due to extreme climate effects. Similarly, 28 (56%) respondents acknowledged an increase in atmospheric temperature impacting livelihood. Lobell and Field (2007) argue that the world's food and nutritional security are at risk due to climate change. The greenhouse effect causes the temperature to rise. The average global temperature is expected to increase by 2 °C by 2100, causing significant global economic losses (Lobell and Field, 2007). The average global temperature is rising steadily because of increased photosynthesis, and the concentration of CO₂ a greenhouse gas in large portions. This increase in CO₂ is causing the Earth's atmosphere to retain

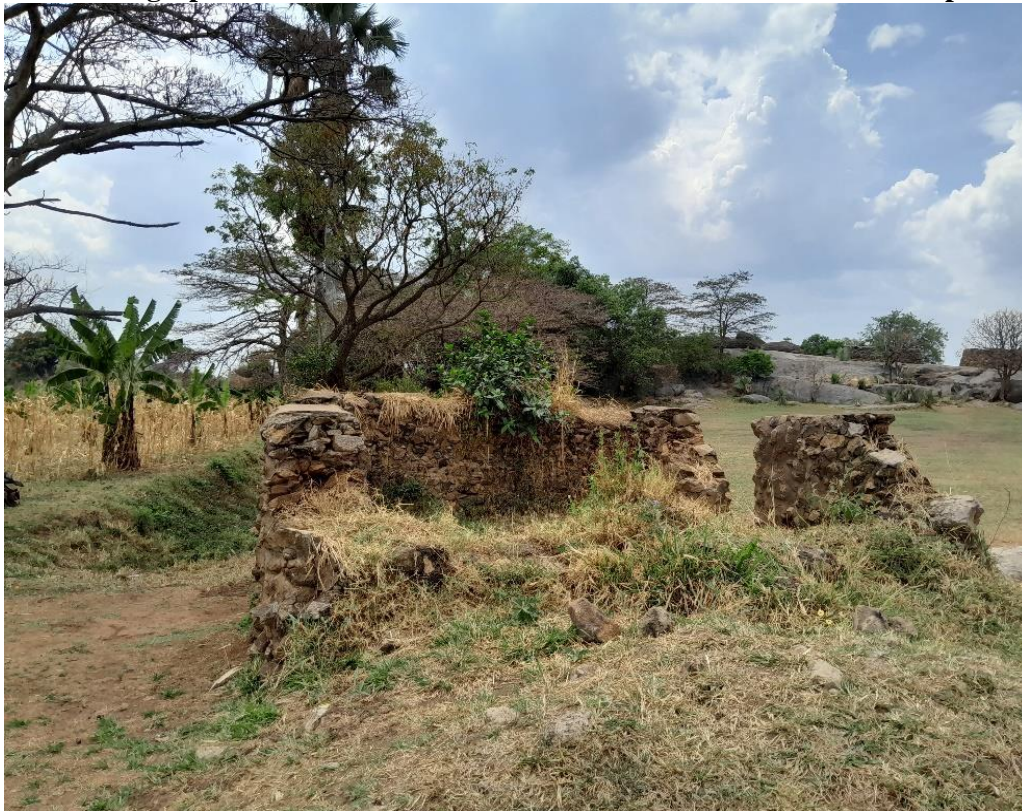
Filed Photograph 6: The 'Gate of No Return' Devasted Due to Rain and Temperature Fluctuations

A respondent mentioned the effect of climate change on the 'Gate of no Return' which according to the measurements, stands six (6) feet on the left side and four (4) feet on the right side. Mr Ronald the historical site caretaker attributed the heights to the rain that penetrates the weak rocks joined together with soil and cement on the outside coverings that weakens the rock and the mud soil thus leading to the breaking of the rock to attain irregular heights. The researcher observed that the rock crumbles down due to increased temperatures in the day which leads to expansion and reduction in temperatures at night leads to contraction thus breaking the rock into smaller particles and gradually leading to the breaking of the joined rock structures in a process called exfoliation. The 'Gate of no return' is most likely to crumble wholly if no action is taken because the left outside part has already developed cracks on the rocks, and plants are growing with the structure.

The 'Gate of No Return' at Fort Patiko, according to Mr Ronald and the researcher, is experiencing significant structural changes due to climatic factors. The irregularity in height is primarily

attributed to rainfall, temperature fluctuations, and biological growth that weaken the rocks and soil cement covering the structure. The study further deduces that rainwater penetrates through weak points in the rock and the outer soil-cement layer covering the gate. Over time, this permeation weakens the bond between rocks and soil cement, leading to instability and potential collapse. Continuous exposure to rainwater causes erosion and weathering of the rock, particularly where the structure is inadequately protected or where cracks and fissures develop.

Diurnal temperature fluctuations, with high daytime temperatures and cooler nights, induce expansion and contraction of the rocks. This phenomenon, known as exfoliation, weakens the structural compactness of the gate over time. The cyclic stress caused by daily temperature changes exacerbates the fracturing and crumbling of the rock structure, contributing to its gradual deterioration. More so, vegetation such as plants growing within cracks and crevices of the gate's structure further accelerates its degradation. Plant roots can penetrate the rocks, widening existing cracks and weakening the structure. As plants

grow, their roots exert pressure on the surrounding rocks and cement, exacerbating the structural weaknesses and contributing to the breakdown of the gate.

Visible cracks on the rocks and uneven height indicate ongoing structural instability. If left unaddressed, these cracks may propagate, leading to partial or complete collapse of the gate. The gate is particularly vulnerable to further fragmentation due to the combined effects of rainfall, temperature variations, and biological growth.

Without intervention, the integrity and historical significance of the gate could be lost. It is important to ascertain that the 'Gate of No Return' holds significant historical and cultural symbolism, representing a poignant aspect of Fort Patiko's history. Its deterioration impacts the physical structure and diminishes its symbolic value and educational potential for visitors and future generations. Conservation of such historical structures is crucial for maintaining cultural heritage and promoting tourism, contributing to the local economy and community identity.

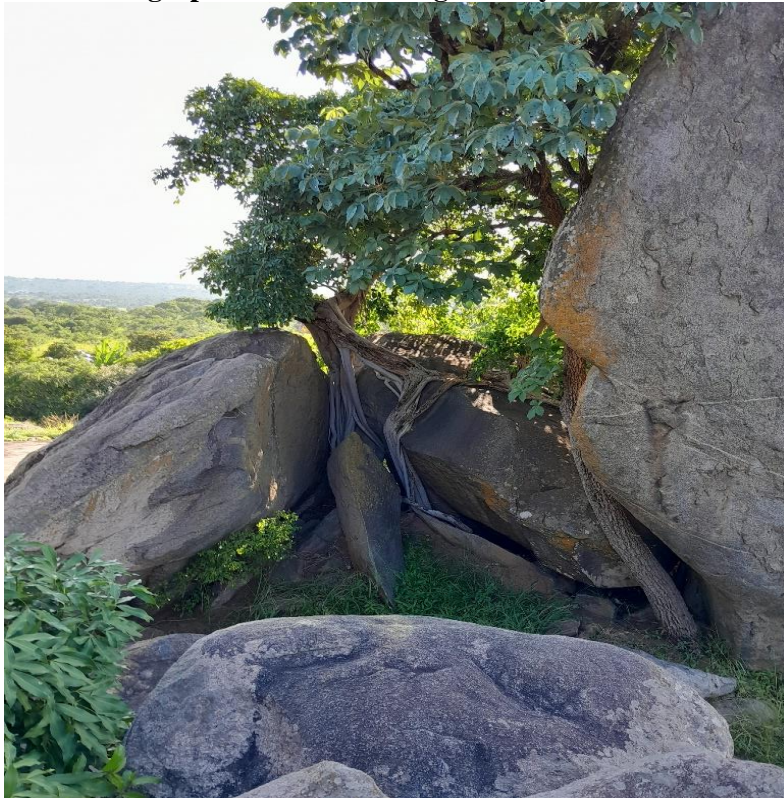
Field Photograph 7: Rocks Disintegrated by Root Pressure

A rock near Baker's lip has already crumbled and it is attributed to temperature fluctuations. Next to the lip is a watch tower that has already shown signs of weakness and will probably split at any time due to temperature fluctuations and the root effect, which is demonstrated by the growing trees in the watch tower's rock patterns at the base; the same watch tower has darker areas that are exposed to heat and sunlight more than the hidden areas, which still have signs of brightness and lustre. Additionally, it was noted that the exquisitely intertwined rock piles have tree plants

growing among them due to rainwater that encourages germination. These trees put pressure on the rocks through their root system, causing the intertwined rocks to break away. Additionally, the rocks are most likely to fall apart following another phase of climate change. Therefore, it is worth noting that the effect of climatic factors, such as high temperature, heavy rainfall and strong winds, attributed to the crumbling of the "Gate of no Return can be preempted on climate change and human activities to some extent.

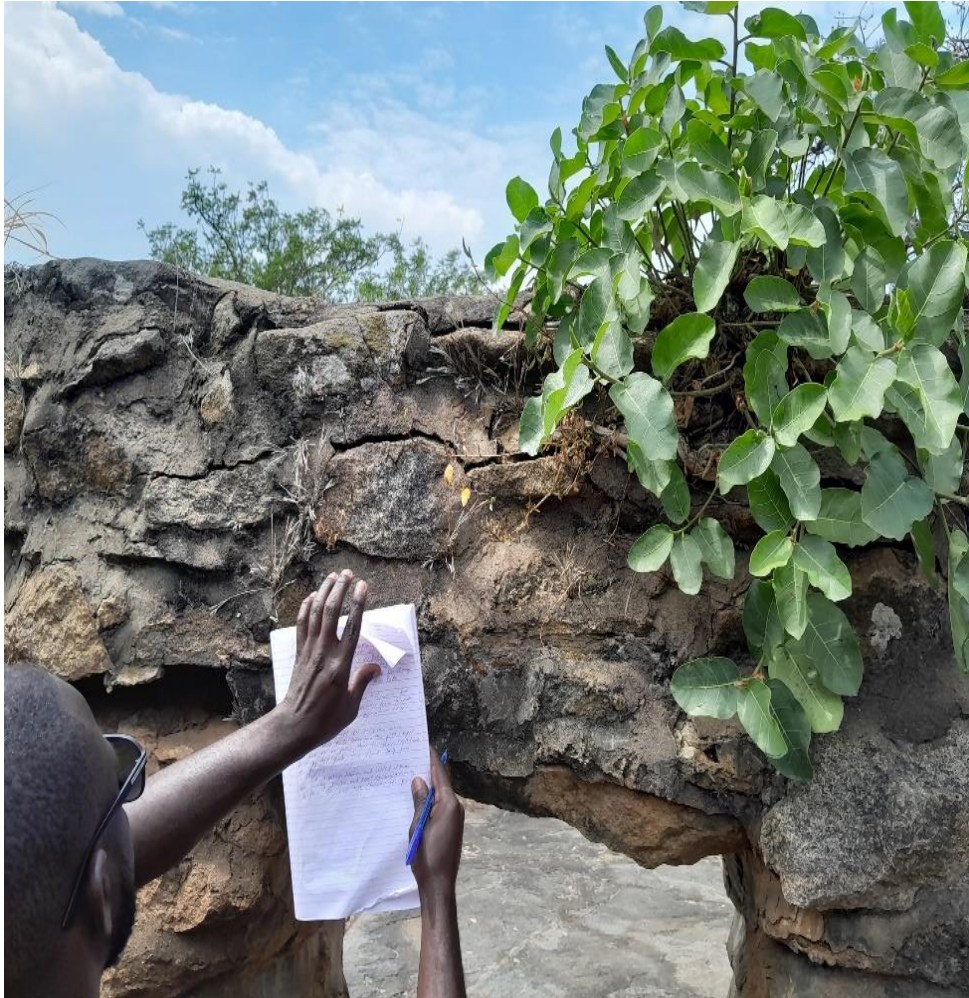
Field Photograph 9: The Armoury Store Affected by Root Pressure

Observations made on top of the rock revealed the effect of climate change on the armoury, millet and the simsim store in that, they have shown evidence of crumbling down. On all three structures, there are cracks observed developing on the wall both internally and outside. This has been attributed to the rainwater that enters the joined rock walls with mud plastered with cement and sand; these three structures were grass thatched offering fresh air to the Arab soldiers and Sir Samuel Bakers soldiers, this no longer exists as it was given in to rainfall that penetrated the grass thus rotting leaving the three structures open. The square building further has shown evidence of growing tree plants with the roots protruding through the wall leaving behind cracks on the walls, it is also projected that the roots will eventually dissect the rocks leading to the crumbling of the rocks and the entire building. Water collects on the floor of the stores which will eventually weaken the wall thus breaking away. Furthermore, apart from the pit latrine built by Amin's government crumbling down, the reception centre has also shown signs of breaking down on the verandas that have been eaten up by running water. The research findings highlight

significant structural deterioration at Fort Patiko, exacerbated by water damage and environmental factors. Specifically, water infiltration and erosion are weakening the walls of storage facilities and other structures like the reception centre, posing risks of collapse and further degradation. Water collects on the floors of the storage rooms, potentially leading to moisture infiltration into the walls. Over time, this moisture weakens the structural set-up of the walls, causing them to deteriorate and potentially collapse. Persistent moisture within the walls promotes mould growth and deterioration of building materials and compromises the structural stability of the facilities.

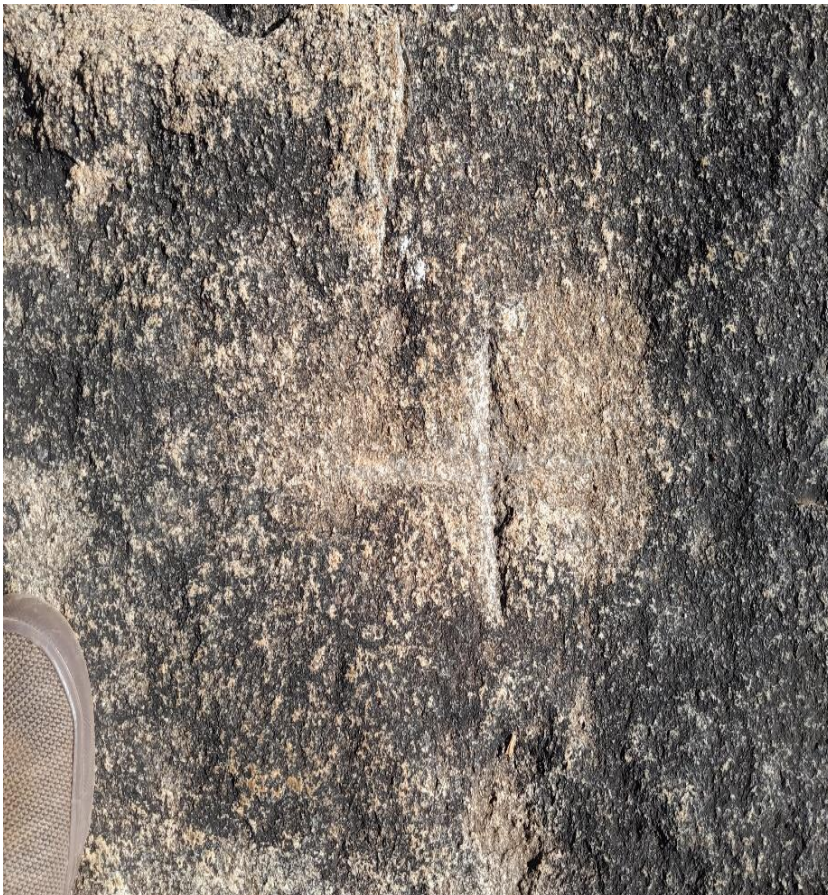
Field Photograph 11: Bakers Cross on the Rock

Additionally, Baker's cross and the moon inscribed by Baker and Arabs respectively are

disappearing due to the high temperature that darkens and tears off the rocks.

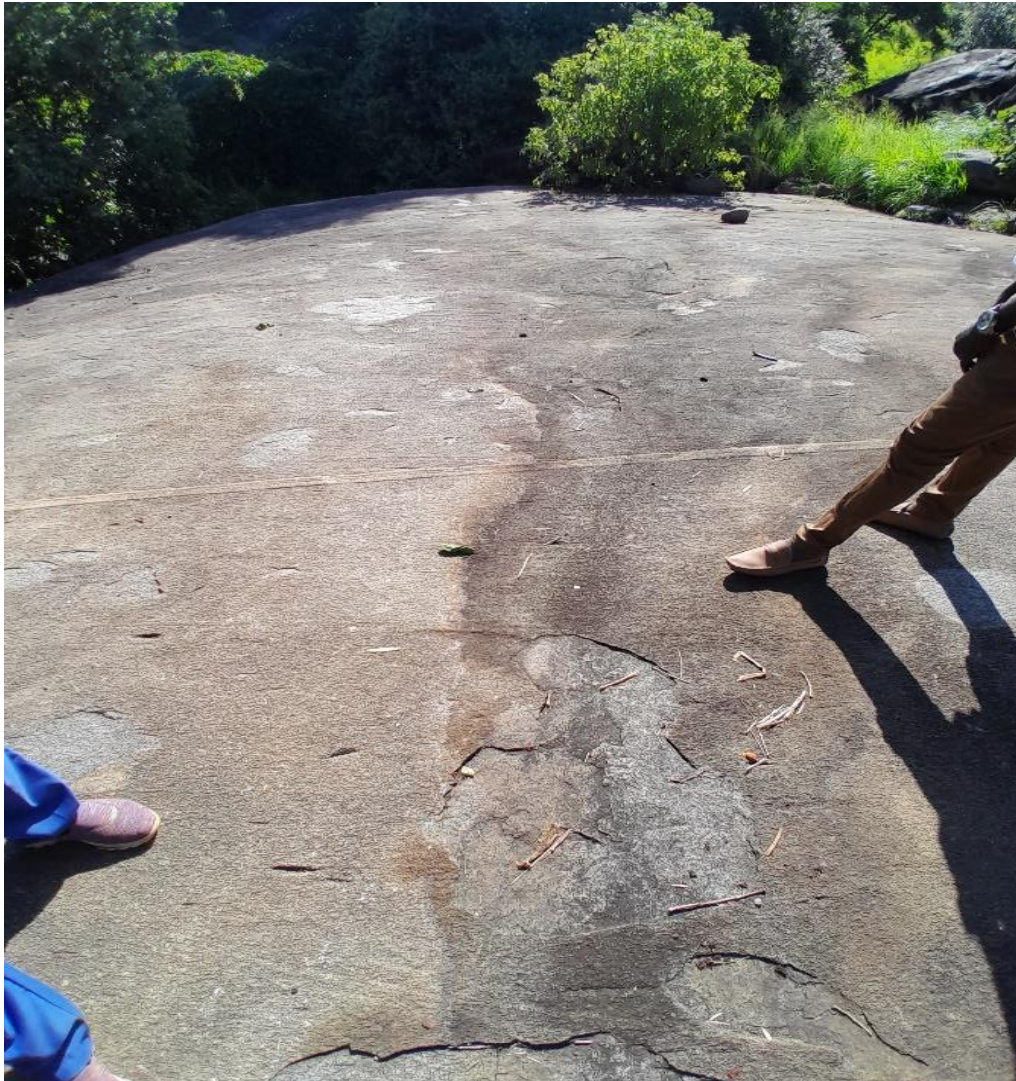
Field Photograph 12: The Execution Slab with the Axe Marks and Possible Dried Blood Stains

The evidence of claimed spilled blood stains and the axe-marks left behind as a result of chopping off slaves' heads are gradually disappearing as running water washes it away daily as well as the sun that darkens and exfoliates the rocks. Fort Patiko holds significant historical value, particularly as a site associated with the tragic history of the slave trade. Evidence of this dark past, such as blood stains and axe marks from the beheading of slaves is crucial for understanding and preserving the site's historical narrative. However, this study highlights that these physical remnants are gradually disappearing due to environmental factors, which threaten the preservation of this tangible heritage. The study attributes this to exposure to running water which erodes the surfaces of the rocks where blood stains and axe marks are present. Over time, the continuous flow of water washes away these historical marks, reducing their visibility and eventually causing them to disappear entirely. The mechanical action of water, especially during heavy rains, can wear down the rock surface, smoothing out the indentations and removing traces of stains and marks. Furthermore, prolonged exposure to sunlight causes the rock surfaces to darken over time. This natural weathering process can obscure the visibility of blood stains and axe marks, making them harder to discern. Lastly, Temperature variations between day and night cause the rocks to expand and contract, a process known as exfoliation. This results in the peeling away of the outer layers of rock, which can gradually erase the surface evidence of historical events. The blood stains and axe marks serve as powerful physical reminders of the brutal history of slavery associated with Fort Patiko. Their disappearance diminishes the site's ability to convey its historical significance and the emotional impact of its past. These physical pieces of evidence are crucial for educating visitors about the history of the slave trade. Their loss would weaken the narrative and reduce the site's effectiveness as an educational resource.
