Environmental & Socio-economic Studies

The damage caused by landslides in socio-economic spheres within the Kigezi highlands of South Western Uganda

An assessment of the socio-economic implications of landslide occurrence in the Kigezi highlands of South Western Uganda was conducted. Landslide occurrence is on the increase and threatens community livelihoods in these highlands. Detailed field investigations were undertaken with the help of local communities between June 2018 and May 2020 to identify and map recent and visible landslide scars in Rukiga uplands of Kigezi highlands. In the course of field inventories, 85 visible landslide scars were identified and mapped using handheld GPS receivers to produce a landslide distribution map for the study area. A socio-economic analysis was conducted to establish the effects of landslide damage on people's livelihoods as well as their existing coping and adaptation mechanisms. The assessment was administered through field observations and surveying, focus group discussions, key informants and household interviews as well as the use of Local Government Environmental Reports. The study established an increase in the spatial-temporal dist

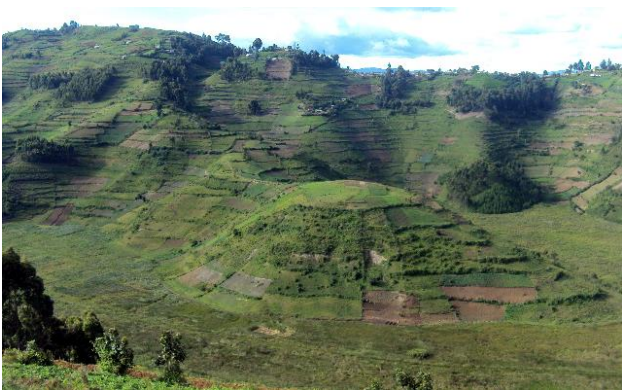
Fig. 3. Intensively cultivated slopes with high vulnerability to landslide occurrence (Photo credit: D. Nseka)

The vegetation cover of these highlands was until about a century ago characterized by montane forests (BAGOORA, 1993). Centuries of human interference has led to serious degradation and in some cases depletion of vegetation cover (CARSWELL, 1997). Currently, except for the few natural vegetation patches surviving under legislative protection, the rest of the vegetation cover in the highlands is either very poor or long gone (NEMA, 2014). The high population for the Rukiga upland region of 105,400 people and a density of 268 people/km² (UBOS, 2018) has put tremendous pressure on the land cover and land use in this region, leading to resource overuse and subsequent degradation (NEMA, 2018). Most of the highlands now comprise poor vegetation cover with various human manipulated or impacted types (Fig. 3).

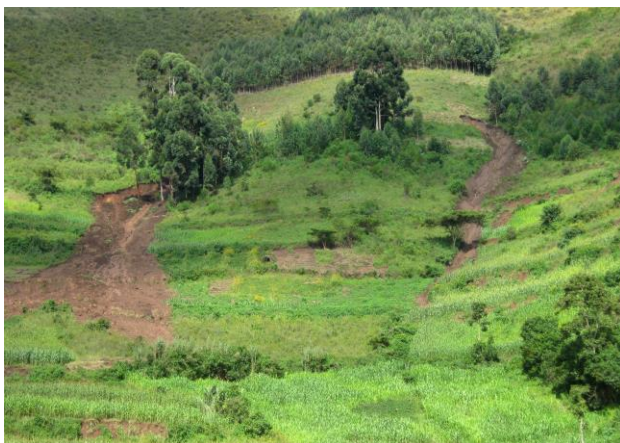
Fig. 7. Landslide occurrence in the study area, 2019
(Photo credit: D. Nseka)

The landslide scars in the catchment varied from small 12.5 m slides to longer complex flows that extended in some cases to more than 890 m. Whereas the average width of the landslide scars ranged between 0.9 to 17.5 metres for small and complex occurrences respectively, the average depth was between 0.5 to 5.3 metres for shallow and deep seated landslides respectively. The mean area covered by each landslide occurrence varied from 125 m² for the smallest landslides to about 6000 m² for large scars. The estimated volume of hillslope materials displaced by individual landslides varied between 62.5 m³ and 30 000 m³ for small and large occurrences respectively. Most of the displaced materials ended up in river channels leading to flow blockage and consequent flooding of the valley floors and flood plains (Fig. 10). Most of the studied landslide scars were initiated in the middle part of slopes rather than in the upper section (Fig. 7). The crown and areas close to the main scarp are commonly marked by the presence of open tension cracks that are between 30 cm and 100 cm wide and were observed at, or close to, the head scarps of most of the slide scars.

In this study, landslide scars were considered to be those features which resulted from past failures but were still visible. Recent landslides were considered as those failures which have occurred within the past 3-5 years and are still active with signs of reactivation especially during the periods of high moisture supply. Out of the 85 visible landslides surveyed in the study area, less than 30% are older landslide scars where margins and head scarp have been degraded. More than 70% are recent slides with well-defined margins, head scarp, and no, or partially developed, drainage channels. Most of the recent scars show signs of reactivation (Fig. 7).

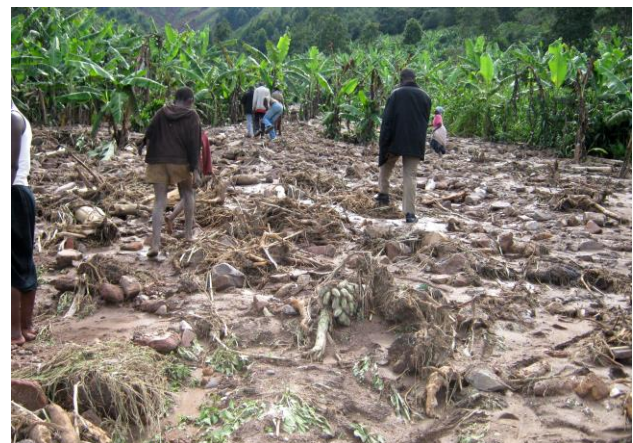
Fig. 8. Farmland and crop destruction by landslide debris, 2019 (Photo credit: D. Nseka)

All 200 respondents in the household interviews reported the loss of prime arable land leading to food insecurity. The study also found that landslides have led to the destruction of farmlands (376.1 hectares), gardens of crops (241.2 hectares) and woodlots (29 hectares) which were covered by material deposited by debris flows and mud flows over the past 10 years (Figs. 8 to 11).

highlands occur on farmlands. They bury crops and make farmlands partly useless for several years. They lead to the demise of small prime agricultural lands due to the deposited debris (Fig. 8). Consequently, farmland has become scarce and pressure on the remaining land is higher. Land shortage due to landslides is indeed one of the main problems facing farmers in the Kigezi highlands (NEMA, 2017). Landslides also remove the productive top soils and render post landslide areas less productive. The loss of fertile soils and farmlands therefore renders these landscapes highly impoverished. It is clear that landslides in these highlands is a significant problem for the local farmers (Figs. 7 to 9).

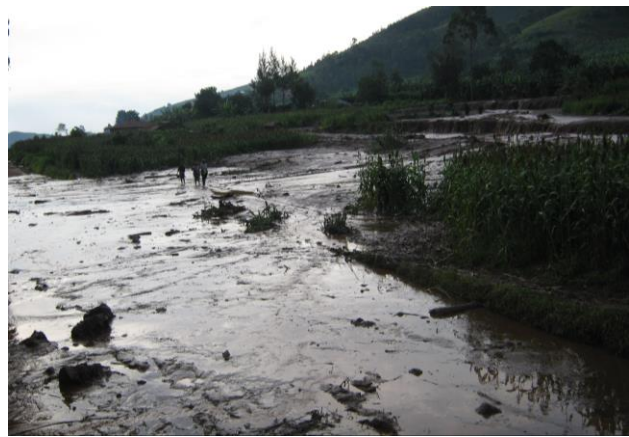
Fig. 9. Destruction and blockage of roads by landslide debris, 2019 (Photo credit: D. Nseka)

Landslide occurrences have led to serious impacts on the socio-economic infrastructure of the region. From the field surveys conducted, the study established that many roads (totalling 247.3 km) were covered by landslide materials and rendered impassable for 3-7 months while 7 bridges were swept away by debris flows and floods over the last 10 years (Fig. 9). From the FDGs and interviews conducted, the study found that landslides have led to the disruption of livelihoods due to destruction of transport infrastructures. There is vivid evidence that such destruction of transport infrastructures hinders movement of agricultural produce to markets. From the interviews conducted, all the 200 (100%) respondents reported a disruption in the transportation of their agricultural produce to markets due to crippled transport infrastructures.

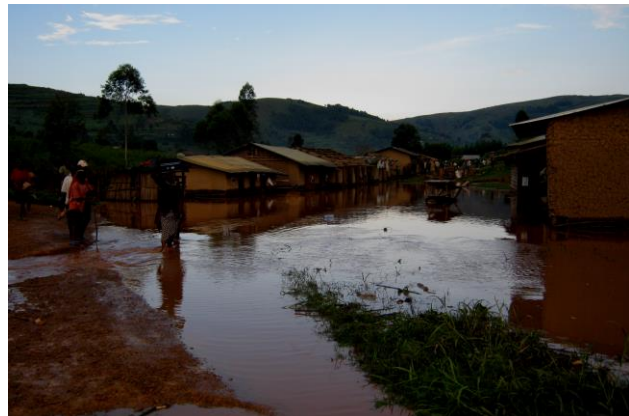
Fig. 10. A flooded township due to stream blockage by landslide debris, 2020 (Photo credit: D. Nseka)

Landslide occurrence in the study area also leads to flooding in valley floors in the lowlands (Fig. 10). The floods result from blockages of streams, wetlands and other drainage channels by landslide materials, and debris flows. The floods destroy farmlands and damage crops especially root tubers (NEMA, 2017). The direct costs of landslide disasters include damage to property and infrastructures (KIRSCHBAUM ET AL., 2015; PFURTSCHELLER, 2018). Similarly, this study established that landslides destroy socio-economic infrastructure especially roads. Landslides have therefore undermined poverty reduction strategies among rural communities which depend on agriculture in these highlands (NEMA, 2018). This study has established that landslide disasters continuously result in human suffering, property damage and destruction of transport infrastructures. Several people in the Kigezi highlands have been forced to settle elsewhere (UBOS, 2018). Landslides in these highlands are therefore associated with many other aftermath effects. The aftermath effects include homelessness, emergence of environmental refugees, famine, reduction in water quality and quantity and huge government expenditure (NEMA, 2014).

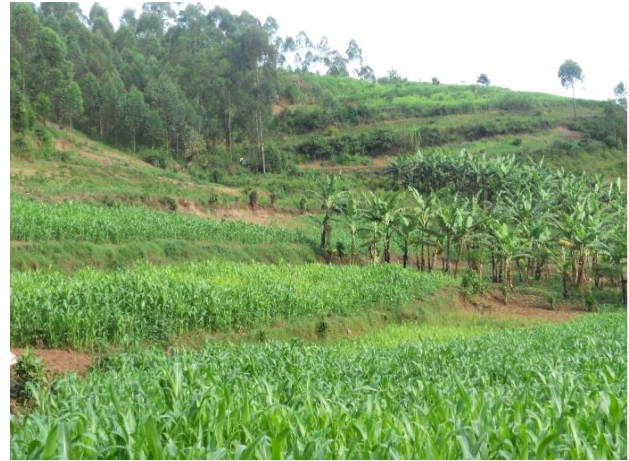
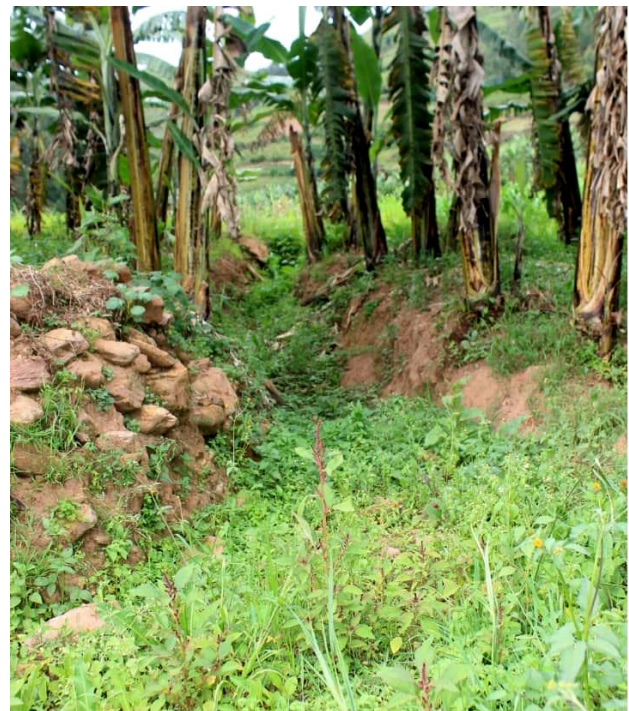
Fig. 12 a, b. Soil, water and land conservation measures to reduce landslide impacts, 2020 (Photo credit; D. Nseka)

From the FGDs, interviews and field surveys conducted, this study found that local communities have devised a range of adaptation strategies to mitigate landslide related disasters. In Karorwa village, for example, communities had dug, and have been maintaining, a storm storage ditch to divert runoff and landslide materials from destroying their houses and farmlands (Fig. 12b). This shows awareness by the people about the likely occurrence of landslides and their associated impacts. The common adaptation strategy was found to be piling soil behind the house, on the upper part of slope so that it can act as a barrier to landslide debris. From the FGDs, interviews and direct field surveys conducted, this study found that farmers have tried to use a number of soil, water and land conservation measures to prevent landslide challenges and also to keep soil fertility. The conservation measures practiced by farmers included mulching involving the covering of top soils with grass, digging water trenches, intercropping, contour banding and terracing among others (Fig. 12a). Close to 90 (44%) respondents interviewed indicated that they had tried to construct terraces to control runoff and landslides (Fig. 12a). More than 120 (60%) farmers interviewed were practicing intercropping to maximize the land available since most of the land has already been destroyed by landslides.
