# Historicizing Natural Hazards and Human-Induced Landscape Transformation in a Tropical Mountainous Environment in Africa: Narratives from Elderly Citizens

**Abstract:** Studying natural hazards in the context of human-induced landscape transformation is complex, especially in regions with limited information. The narratives of the elderly can play a role in filling these knowledge gaps at the multi-decadal timescale. Here, we build upon a citizen-based elderly approach to understanding natural hazard patterns and landscape transformation in a tropical mountainous environment, the Kigezi Highlands (SW Uganda). We engaged 98 elderly citizens (>70 years old) living in eight small watersheds with different characteristics. Through interviews and focus group discussions, we reconstructed historical timelines and used participatory mapping to facilitate the interview process. We cross-checked the information of the elderly citizens with historical aerial photographs, archives, and field visits. Our results show that major land use/cover changes are associated with a high population increase over the last 80 years. We also evidence an increase in reported natural hazard events such as

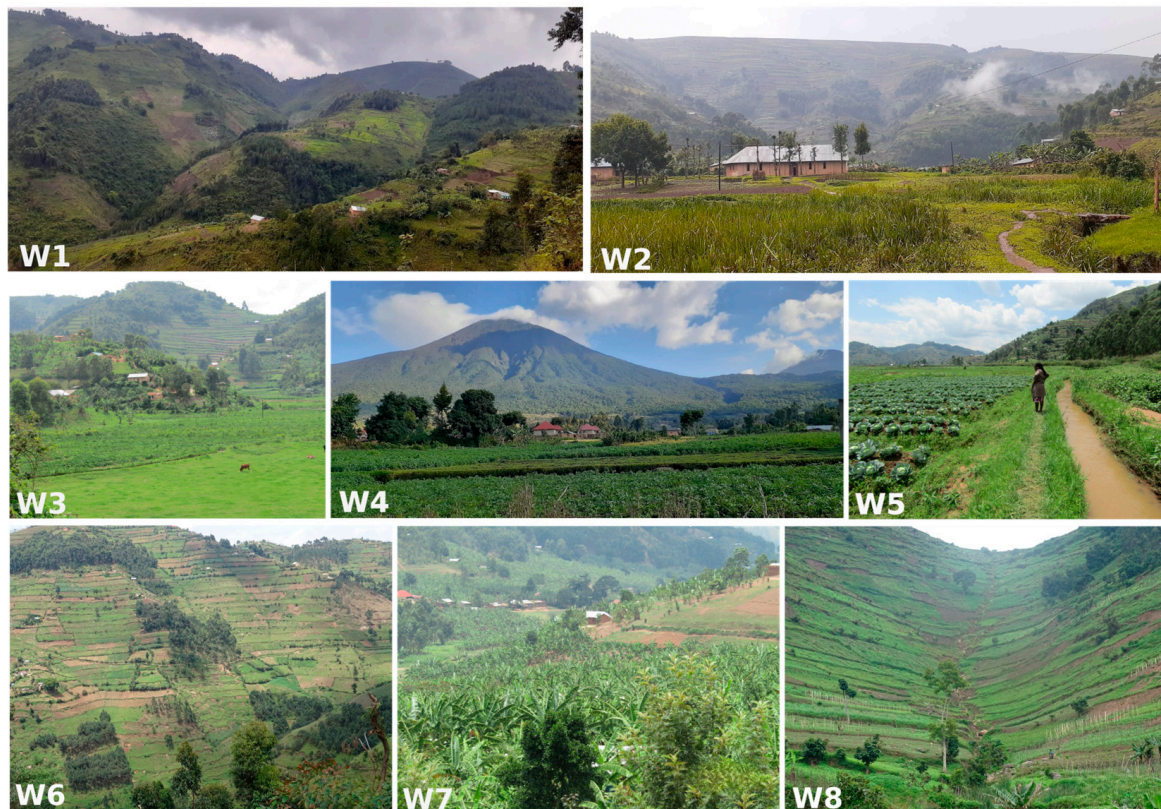
**Figure 2.** Field pictures of the eight watersheds (W1 to W8) illustrating dissimilar topographic and land use/cover characteristics. Photos taken by Violet Kanyiginya during fieldwork in September and October 2021.

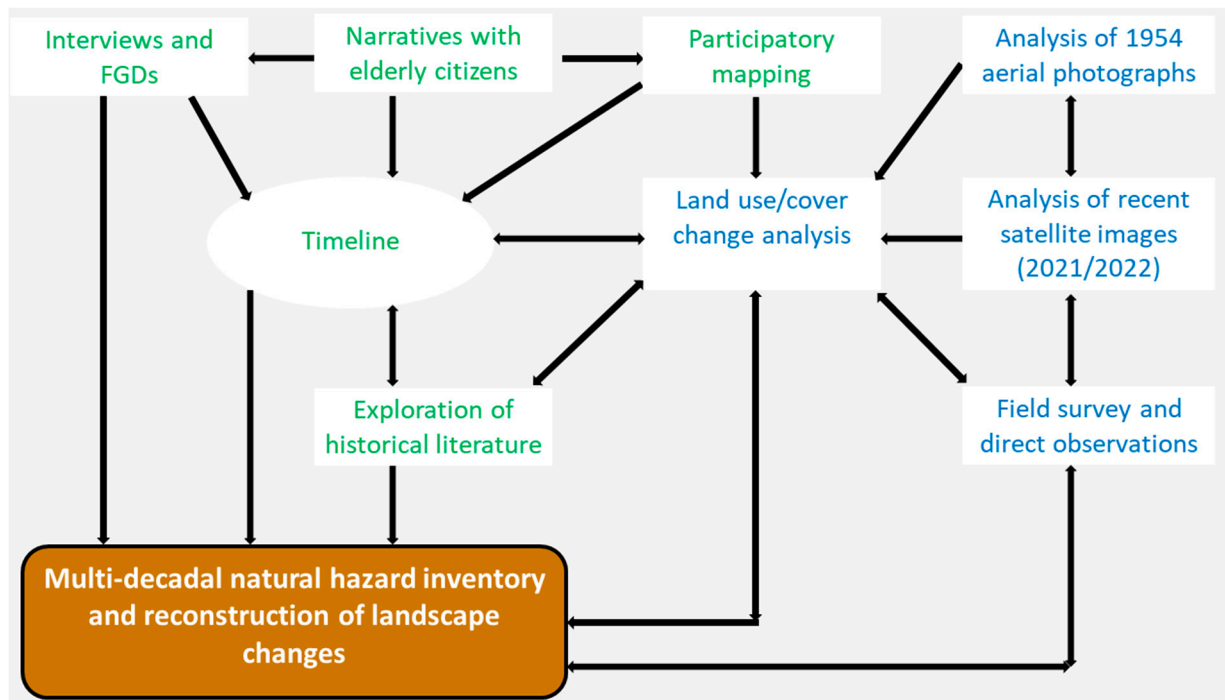
**Figure 3.** The methodological framework of the study illustrating how the multi-decadal inventory of natural hazards and landscape changes was achieved through a combination of historical narratives/approaches (in green text) and empirical methods (in blue text).

In this study, we engaged elderly citizens to gather their insightful narratives about past natural hazard events and landscape changes (Figure 3). This approach addresses the challenge of historical data scarcity, as elderly individuals often possess extensive knowledge and insights about historical landscape transformation due to their long-term interaction with the environment [36–38]. The elderly approach enables combining local knowledge with scientific knowledge, which is essential for the reliable and accurate monitoring of the environment [58].

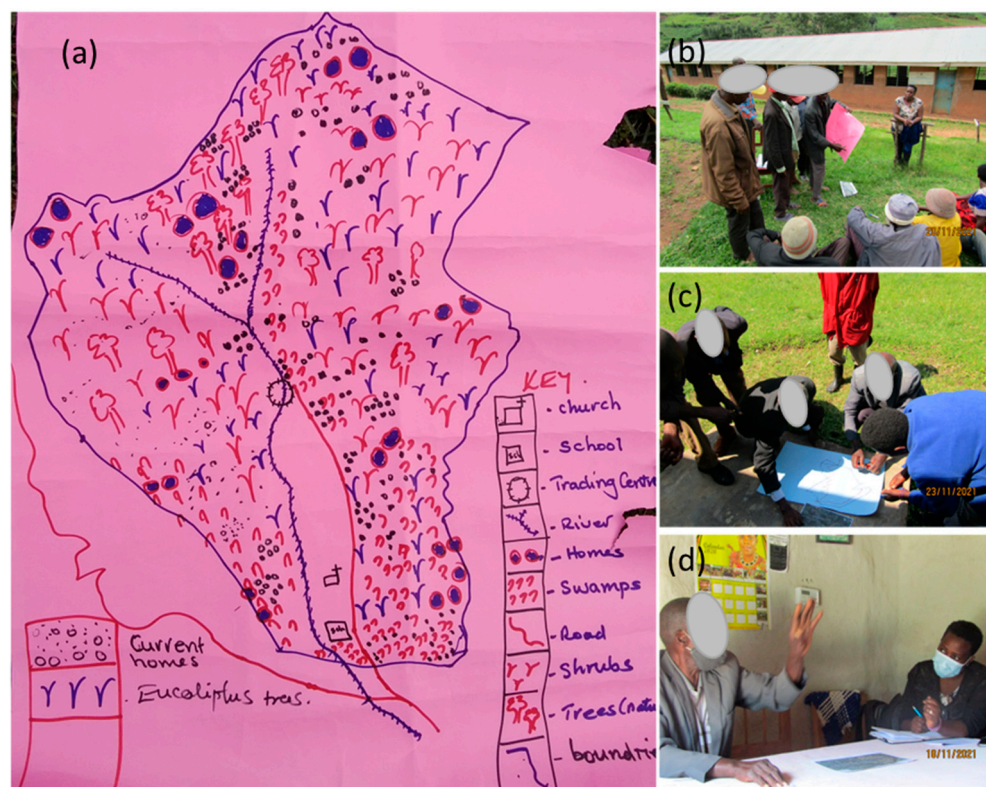
**Figure 4.** Interviews and participatory mapping with the elderly citizens. (a) One of the maps drawn by the elderly citizens during an FGD in W6, showing past (blue marker) and current (red marker) land use and cover. (b,c) Participatory mapping during FGDs with elderly citizens in W2 and W5, respectively. (d) An individual interview session with an elderly citizen in W8. Photos taken by David Mubiru in September 2022.

For the eight FGDs, we applied the participatory mapping technique, where the elderly drew on manila papers the past (i.e., from the 1940s) and current (2021) land use/cover of their land (Figure 4). The mapping was guided by providing the exact delineation of the watershed boundaries as background information. The elderly citizens indicated (1) the locations and numbers of buildings and roads, and (2) the extent of croplands, tree cover, wetlands, and water bodies. Colored markers were used to distinguish between past and present land use/cover (Figure 4).

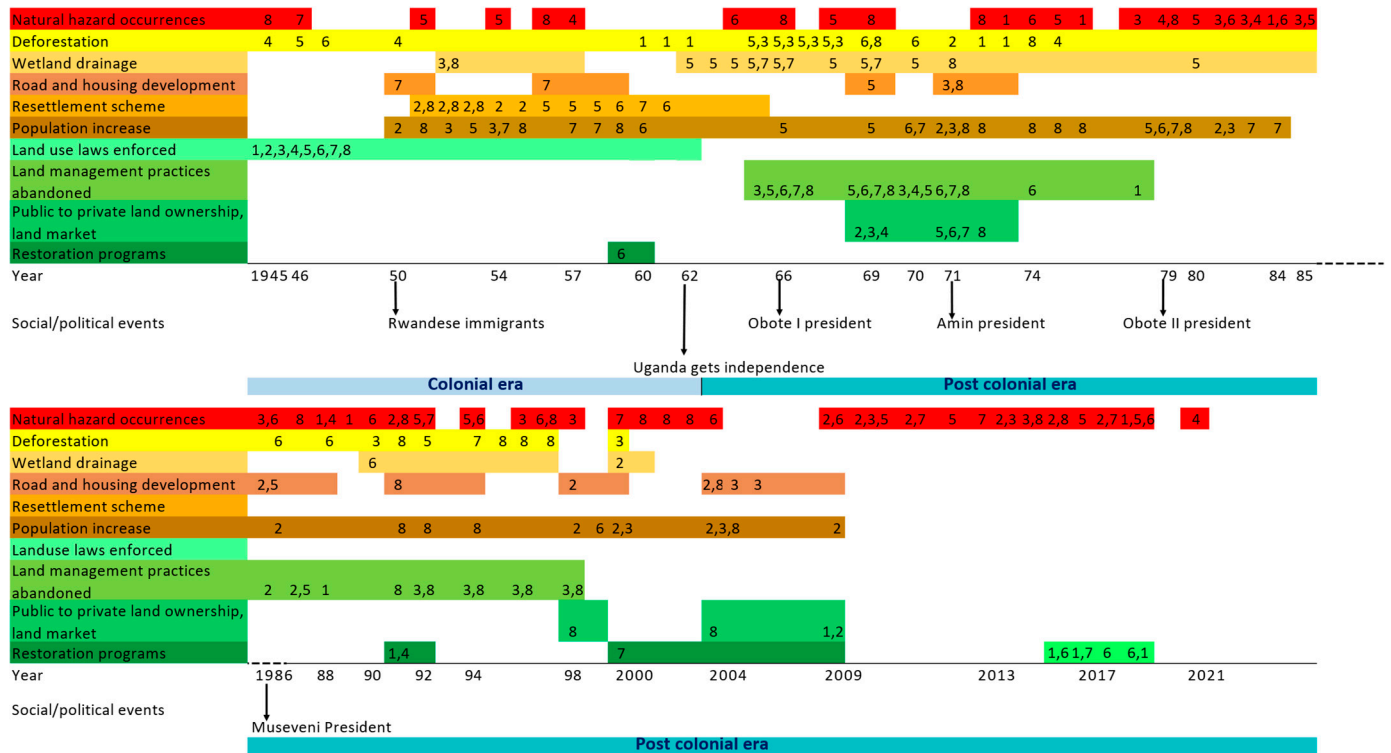
**Figure 5.** Timeline of events constructed from elderly interviews. The numbers represent watersheds where a particular event happened. “Natural hazard occurrences” includes landslides, floods, and gullies associated with flash flood events. “Deforestation” includes natural tree species that were cut down. “Wetland drainage” refers to the reclamation of wetlands for agricultural and construction purposes. “Road and housing development” includes the roads that were constructed and a change from grass-thatched to iron-roofed houses. “Resettlement schemes” are the measures implemented to depopulate the region. “Population increase” includes the increase in the numbers of both people and livestock, land shortages, and overcultivation. “Land laws enforced” includes the land management regulations that were followed during the colonial period. “Land management practices abandoned” includes the end of practices such as fallowing, the planting of native tree species, contour strip cropping, the avoidance of bush burning, and stabilizing contours with elephant grass. “Public land to private land ownership” refers to the time when land titling began to be given to individual owners and the rights of buying and selling land were established. “Restoration programmes” includes initiatives that have been implemented to rehabilitate the degraded landscapes like afforestation, diversion channels, and the creation of forest buffer zones.

According to the elderly citizens, natural hazards were experienced in some watersheds as early as 1945 (Figure 5). However, they noted that these events did not cause severe damage, and their frequency was low at the time. For example, in W8 a large event involving the co-occurrence of landslides and flash floods happened in April 1945, but it did not cause human or property losses since it affected locations that were not inhabited. Despite the low population in the past, the elderly citizens reported that landslides frequently occurred in W8 during the colonial period. One village in W8, for instance, was named after landslides: Nyamutenguzi (literally meaning ‘the sliding land’ in the Runyankole–Rukiga dialect) a name that has remained to date. According to the elderly citizens, residents always relocated from Nyamutenguzi during the rainy season for fear of landslides. Similarly, the elderly in W5 reported the occurrence of landslides in the 1950s, which led people to avoid living on steep slopes for fear of these hazards. However, the elderly confirmed that flooding never existed before 1962, when the wetland was still in existence in W5. In addition, the elderly in W5 indicated that there were natural waterways which effectively drained the watershed during periods of excess water. They asserted that a desilting schedule existed in the community to maintain the channels, which prevented floods. The desilting practice was, however, abandoned after colonial rule in 1962, leading to the channels becoming silted and flooding starting to occur, as reported by the elderly citizens. The elderly acknowledged that the frequency of flooding worsened in the 1980s when the wetland was completely drained for cultivation and settlements. Today, the watershed experiences severe flooding every rainy season. In contrast, other watersheds like W1, W2, and W3 did not experience natural hazards during the colonial period (Figure 5).

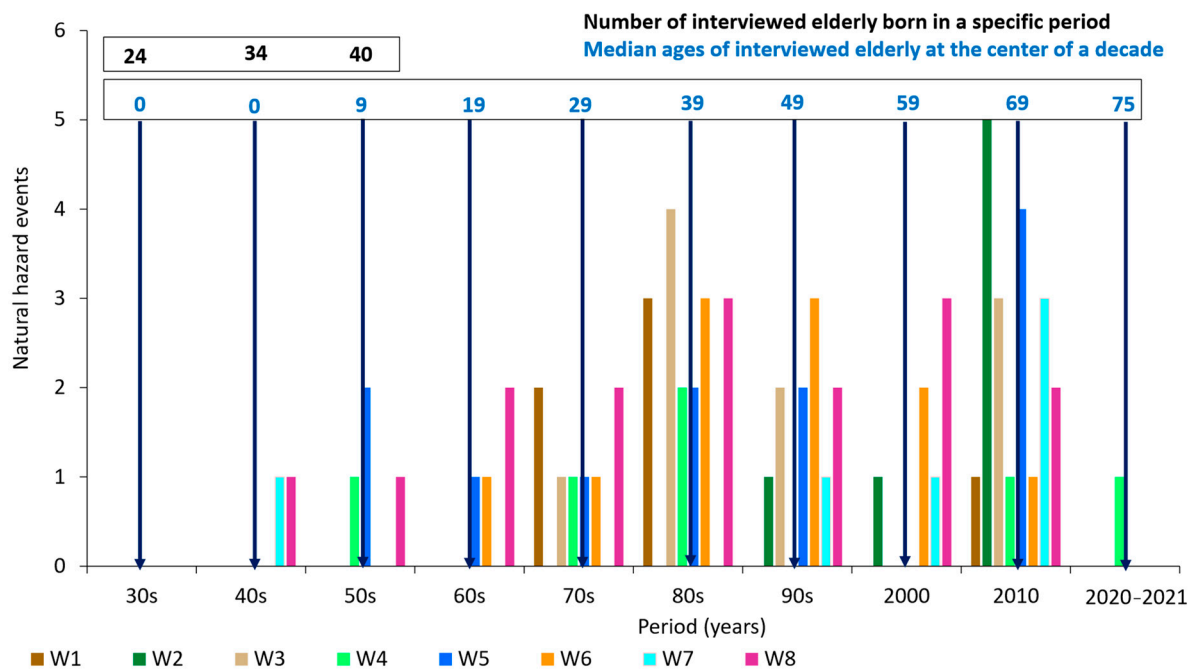
**Figure 6.** The temporal trend in natural hazard events recorded for each decade as per the elderly citizens between 1940 and 2010 and the corresponding median ages of the participants calculated for the middle of each decade. Note that the column for 2020 corresponds to only 2020 and 2021.

Our analysis of the trend in reported hazards in relation to participant ages (Figure 6), shows that few or no hazards were reported for periods when the participants were younger (e.g., the 1940s). In contrast, more hazard reports concentrate in periods when the participants were middle-aged or older (typically 30 years and above). Notably, the 1980s show a high number of events and this coincides with a period when the median age of the elderly participants was 39, an age where they likely recall significant environmental changes [66].
